Study of Damaged Wushi Bridge in Taiwan 921 Earthquake

By Yao T. Hsu¹ and Chung C. Fu², Members

Abstract: This paper reports on the damage of Wushi bridge in a recent Taiwan 921 earthquake. Damage to Wushi bridge appeared in the superstructure, the substructure and the approaches. Typical types of damage are discussed and illustrated in this paper. A review of the bridge design specifications in Taiwan is also presented to give the background on the seismic design of Taiwan highway bridges.

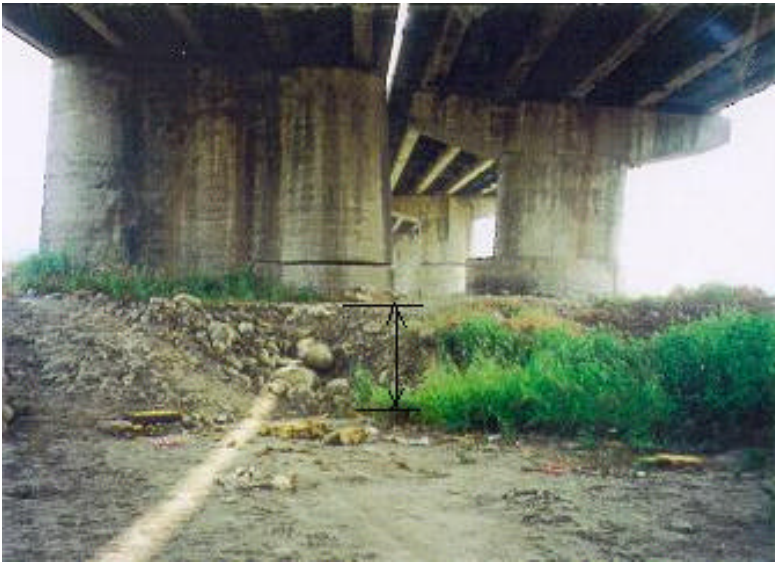
The Wushi bridge is a river crossing bridge and it incidentally crosses the Chelongpu Fault. The northern end of the bridge was the more severely damaged. One side of the fault was lifted vertically about 2.1-2.3 meters. Movement along the bridge's longitudinal direction was estimated to be about 2.2-2.3 meters and the movement along the bridge's transverse direction was about 2.1-2.3 meters. The third span of the northbound bridge crosses the subduction zone boundary with 45° reverse fault movement. The movement caused the superstructure of the first several spans to fall to the ground. Inspection (Fig. 5) showed clear evidence of fault uplifting on both sides of the fallen spans.

Figure 5 - Oblique Fault Movement between Piers P3N and P3S

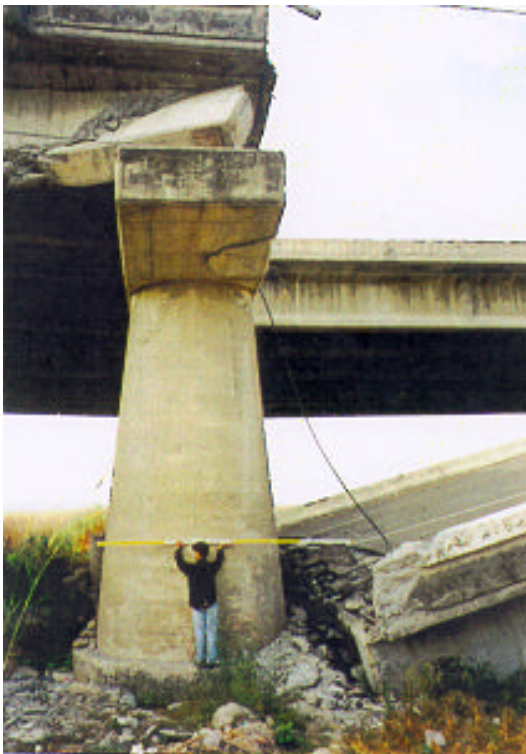
- (3) **Superstructure Failure:** The main reason for the severe superstructure failure was the major fault movement in the horizontal and vertical directions. Since the fault line intersects the bridge at 45 degrees, the superstructure pushed and pulled in the longitudinal direction and, in the mean time, impacted upon the shear blocks in the transverse direction. Due to large movements, the bridge

collapsed with fallen beams on the first two spans. Span failure in this case was due to unseating, which includes pier tilting, insufficient seat length and inadequate restraining force capacity.

Figure 6 - Fallen Beam due to Superstructure Movement in the Longitudinal Direction at Pier P2N

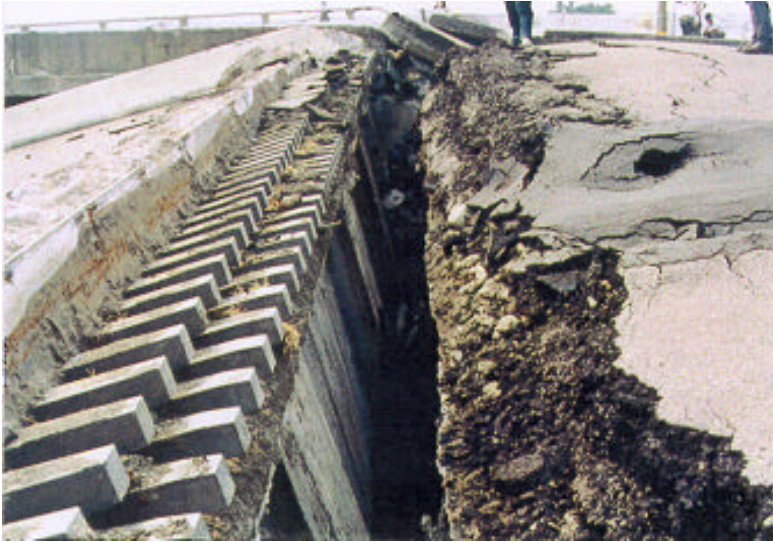
- (1) **Abutment and Wingwall Failure:** Potential slumping at bridge abutments has traditionally been ignored during design in Taiwan. As far as earthquakes are concerned, there are two types of bridge abutments: integral abutment and seat-type abutment. The essential difference is that one (seat-type) permits relative movement to occur between the superstructure and end support and the second type (integral) does not. After filling the gap between the seat and the abutment back wall in Wushi bridge, the backfill and road surface did not allow further movement. Impact of the superstructure generated high passive pressure, resulting in rotation with damage to the top and pile supporting system. The recommendation for minimizing the drop of the road elevation is to be able to install approach slabs. Simple span reinforced concrete slabs can be designed with a minimum length of 3 meters for the approach slab. Figure 7 shows clearly the back-fill settlement. It has also been learned that abutment back-wall, back-fill and approach slabs should be carefully designed and constructed to prevent collapse.

Figure 7 - Backfill Upward Movement at the North Abutment of the Northbound Bridge

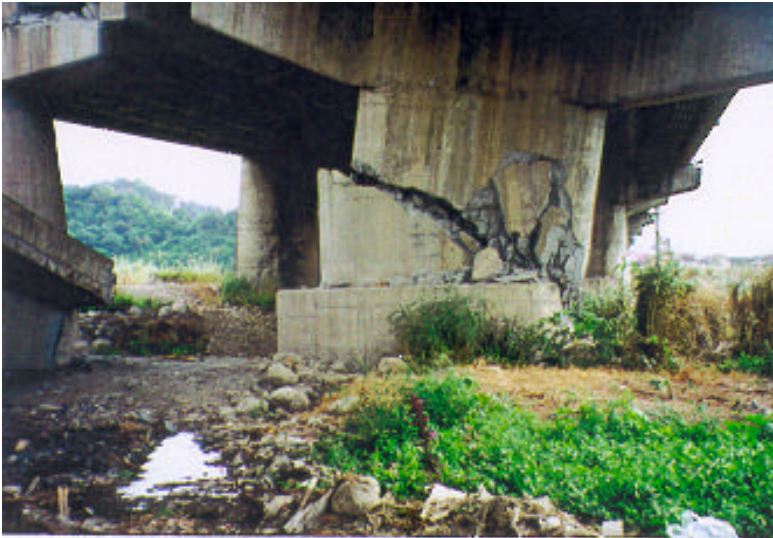
- (2) **Substructure damage:** Wall piers and hammerhead single column piers are used in substructures on north- and southbound, respectively. It is well known that it is economically feasible to design columns to yield and dissipate significant amounts of energy and to perform in a ductile manner. However, with relatively short columns and much stiffness in the transverse direction, shear cracks appeared on piers P1S, P2S, P3S, P5S, P7S, P8S. Typical shear crack shows in Figure 8. Shaft foundation was used in Wushi bridge to support piers. Since the fault line crosses between piers 2 and 3, parts of the foundation, especially ones close to the fault line, were severely damaged and some settled (Fig. 10).

Figure 8 - Shear Cracks on the Southbound Hammerhead Concrete Pier p2S

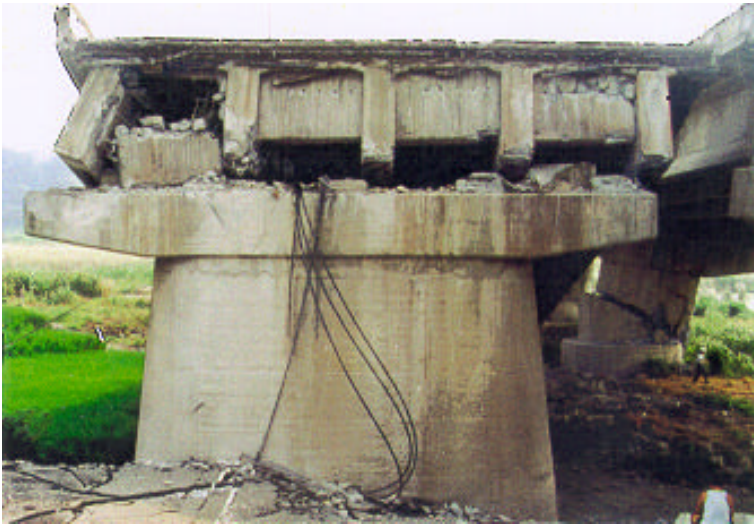
The record closest to the site was made at the Freefield Strong Seismic Station TCUD71, which is about 5.5 Km southeast of the nearest town of Chao-Fung. After the Chi-Chi earthquake, Wushi bridge was severely damaged and the road was closed. Due to the slip movement, the first and second spans of the northbound bridge fell to the ground and the third span clearly showed lateral movement (Fig. 6). The northern end abutment of the northbound bridge was pushed by the span and the jigsaw type of expansion joint and the backwall board were demolished. Under the pressure, the backfill was pushed by the superstructure and moved upward (Fig. 7). Under horizontal vibration, substantial shear cracks showed on the southbound hammerhead concrete pier (Fig. 8). The cap of the first pier of the northbound bridge (PIN) cracked and the East side exterior PCI beams were flexured. The end diaphragms and shear blocks designed to prevent concrete beams from moving laterally were crushed as the whole superstructure moved westward (Fig. 9).

Figure 9 - Crushed End Diaphragms and Shear Blocks at Pier P1N

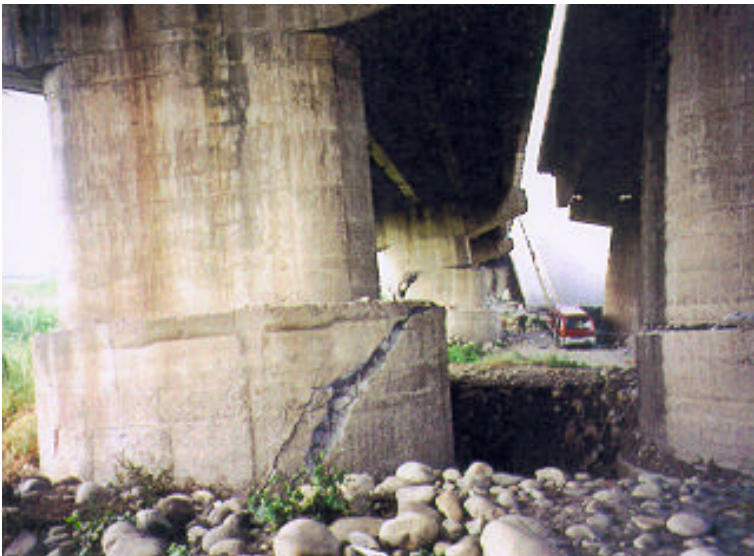
Figure 10 - Pier Settlement and Shaft Shear Cracks at Pier P3N
