**Status Report
on
MDTA Link Slab Study**

**By Dr. Chung C. Fu, P.E., Director and Research Professor
The Bridge Engineering Software and Technology (BEST) Center
Department of Civil and Environmental Engineering, University of Maryland**

Attachment A

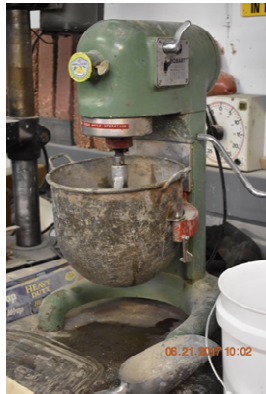
(a) Small Mixer

Figure 1 – ECC lab mixes at Ready Mix Concrete Lab in Greenbelt, MD

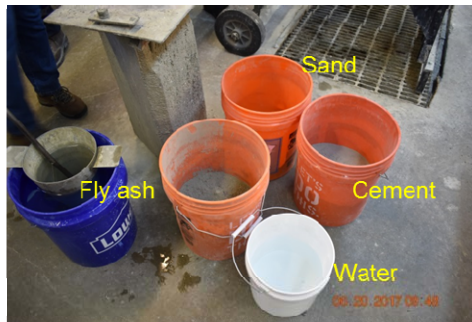
(d) Mixing Material
- Fiber, Cement, Sand,
Fly ash, Water reducer
(not shown), and Water

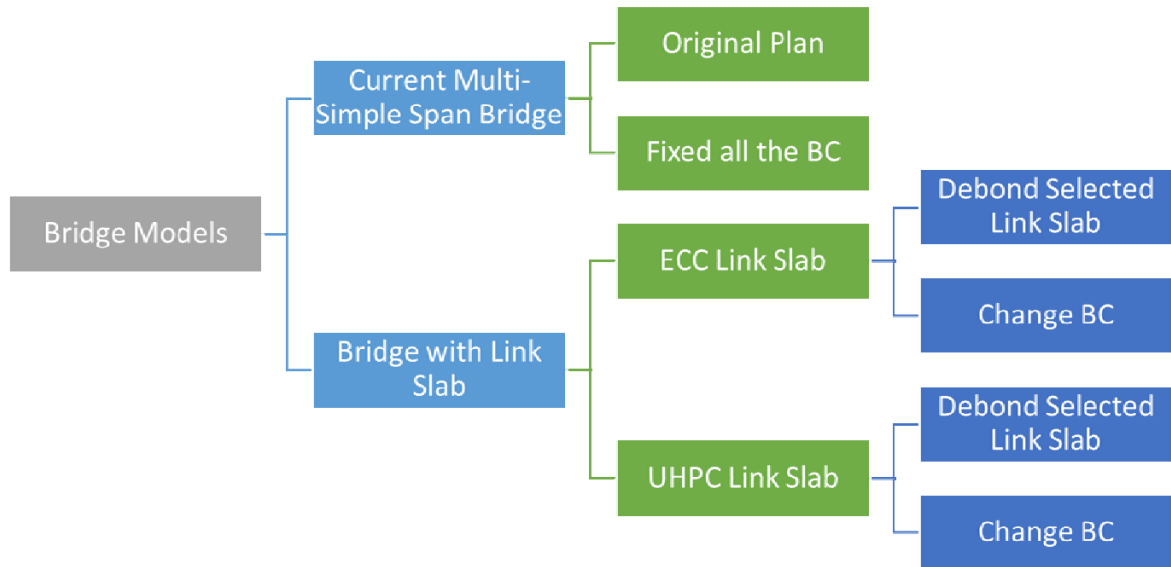
Figure 7 – Feasibility analysis of the prototype bridge

Based on previous literature reviews and meetings, link slab behaviors would be influenced mostly under Live Load and thermal movement. Results and findings are based on comparisons under these loading conditions.

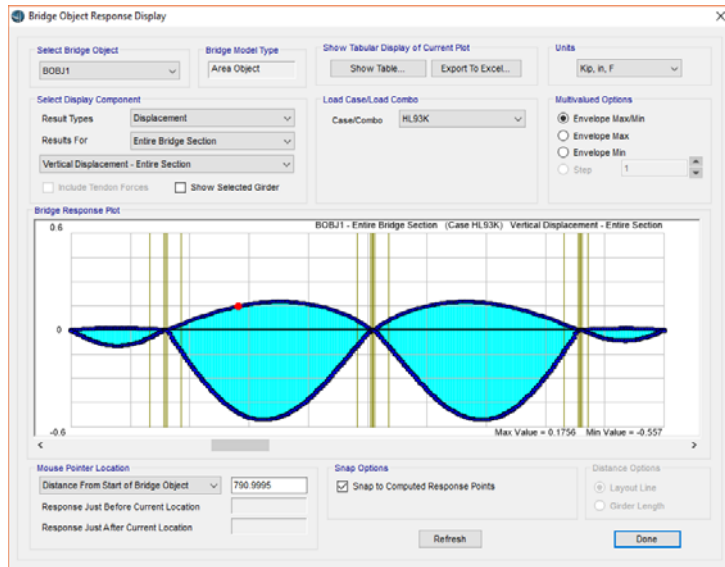
(a) Vertical displacement

(b) Longitudinal stress of slab

Figure 17 –Behaviors of bridges with ECC link slab (left and middle) and RC Link Slab (right, change of debonded zone at the right span) under Live Load

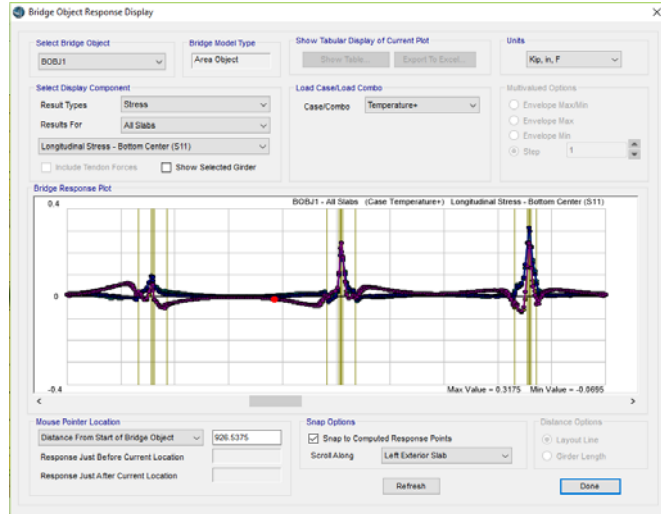
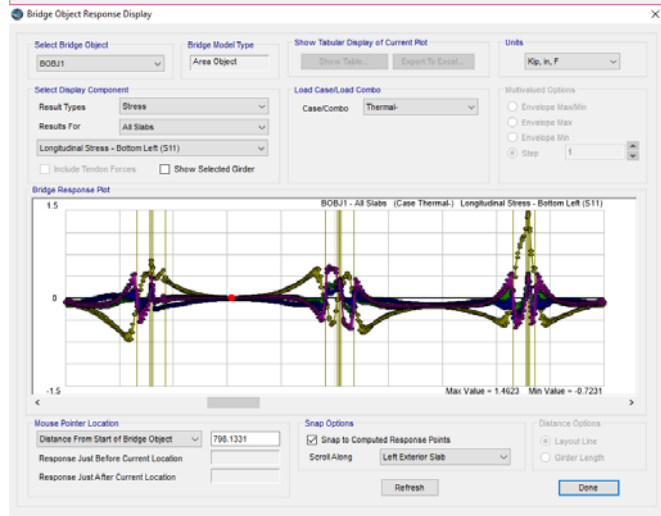
(a) Stress at the bottom of the slab due to positive temperature gradients

(b) Stresses at top of the slab for temperature decrease of 110F°

Figure 20 –Thermal behaviors of bridges with ECC link slab and RC Link Slab

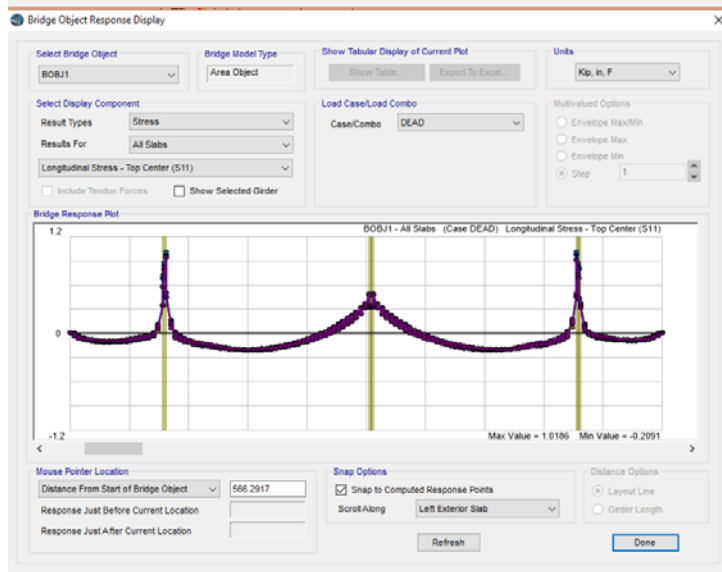
(a) Vertical displacement

(b) Stresses at the top of the slab

Figure 25 –Behaviors of bridges with UHPC link slab under dead load

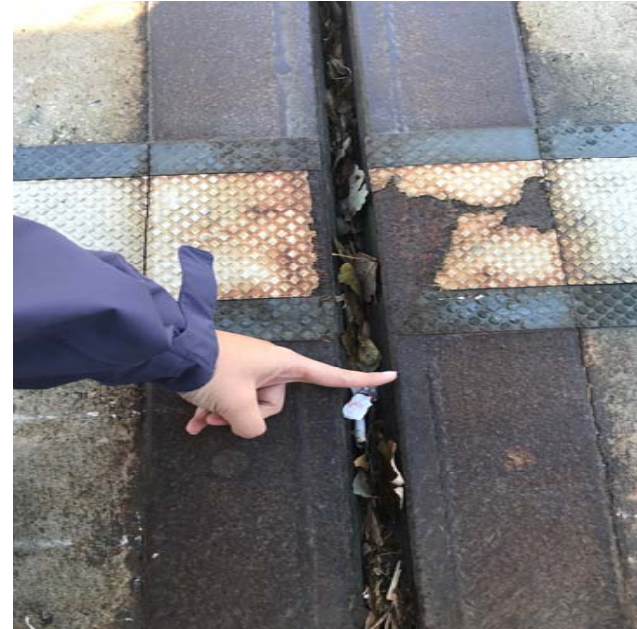
Figure A3 – Exterior pier top deck expansion joint

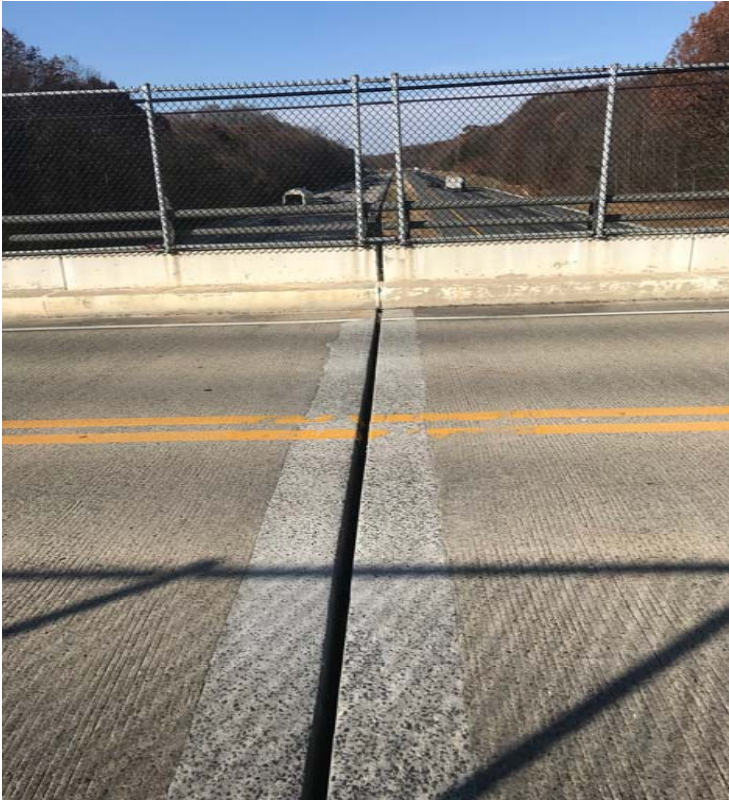
Figure A4 – Interior pier top deck expansion joint

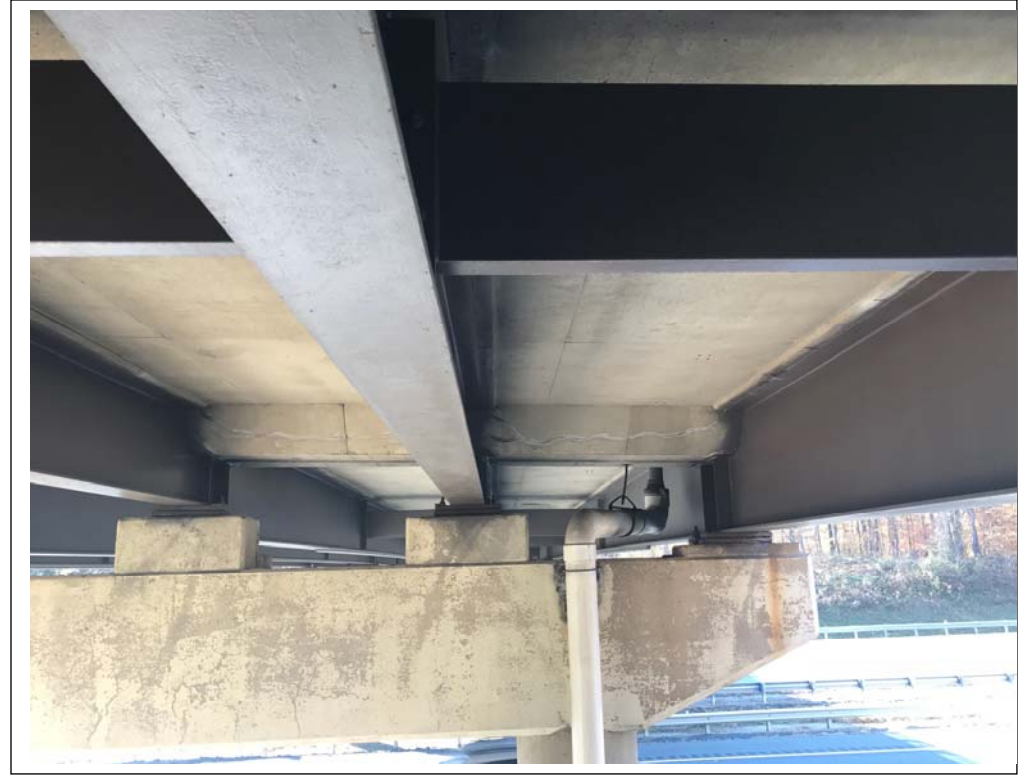
Figure A5 – Exterior pier bearings

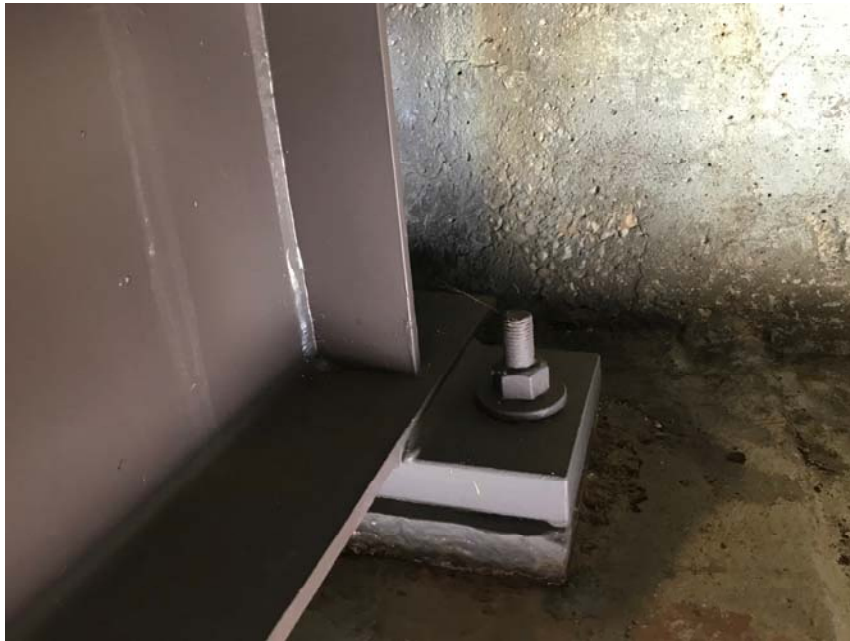
Figure A6 – Abutment fixed bearing

- At abutments fixed bearings are specified for current bridge bearing arrangement. MDOT (SHA Standards) specifies the same details for the expansion and fixed bearings for spans under 50', but the former one with slotted holes and the latter one without. If slotted holes are introduced for the fixed bearings at abutments, we may treat them as expansion ends and thermal stresses could be released. The question is whether it is feasible or not in real situations. If feasible, the boundary conditions of this 4-span case can be treated as RRHRR and the link slab option is feasible numerically (, which is recommended to be validated physically.) In NYSDOT bearings are all replaced by elastomeric bearings and the 3-span case are treated as RHRR.

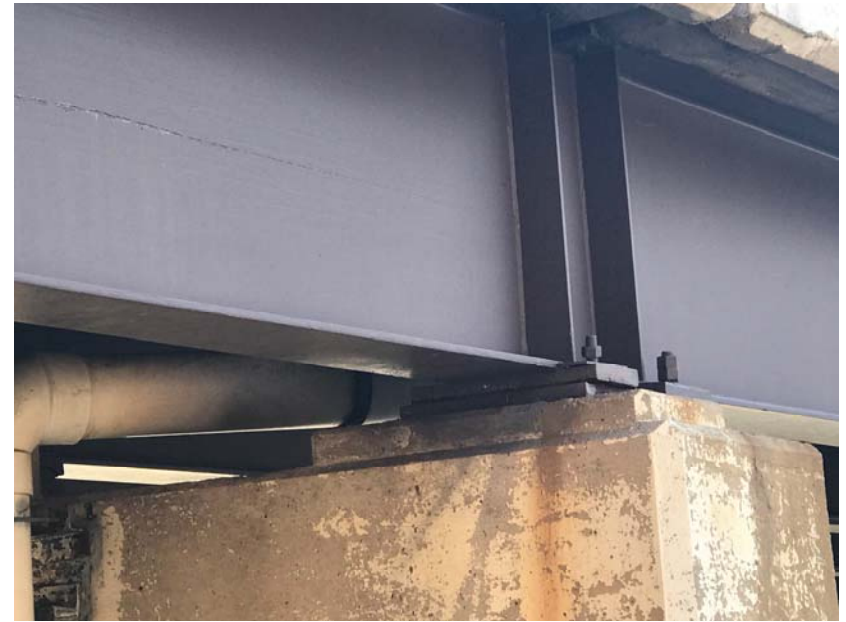
Figure A7 – Exterior pier extension bearings

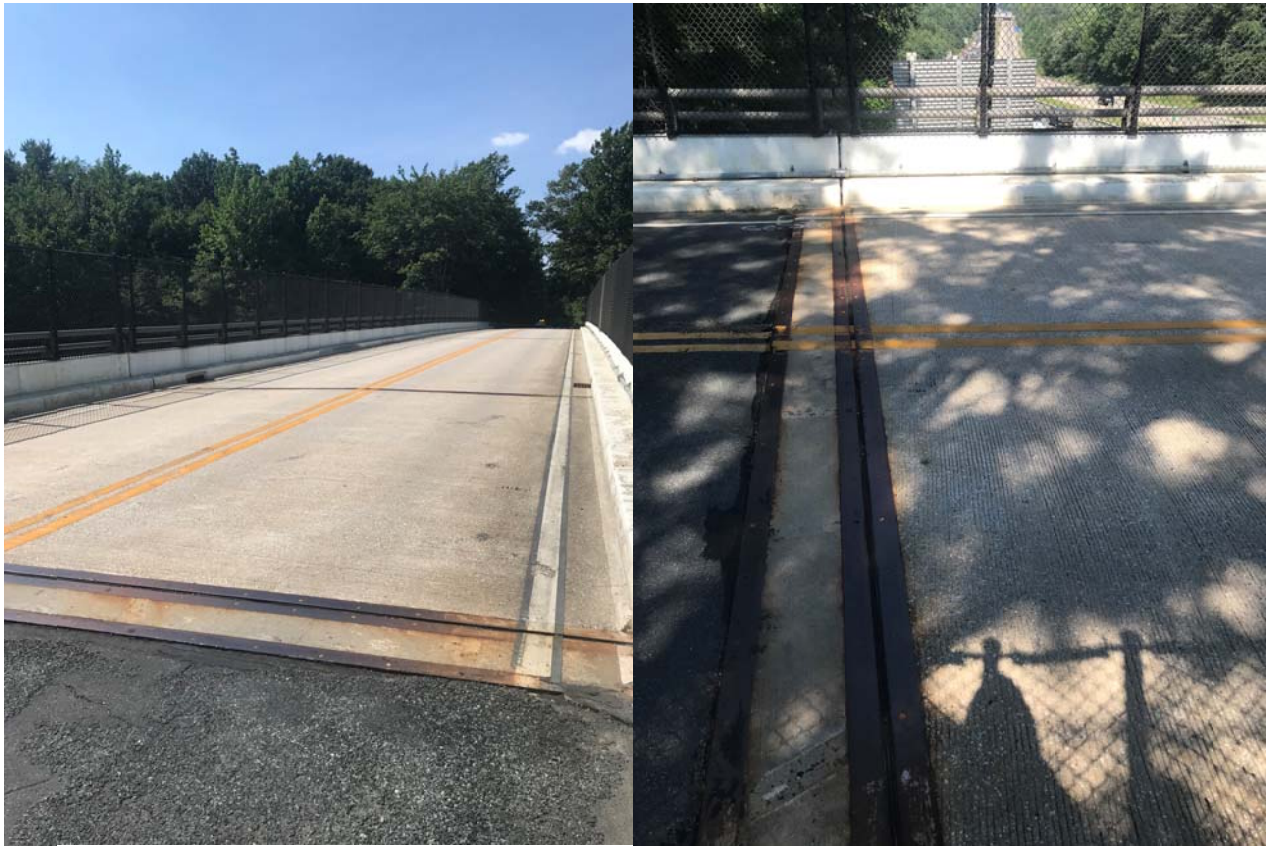
Photos of CEX95200 taken by the BEST Center during field visit (Girders, bearing condition and substructures cannot reach)

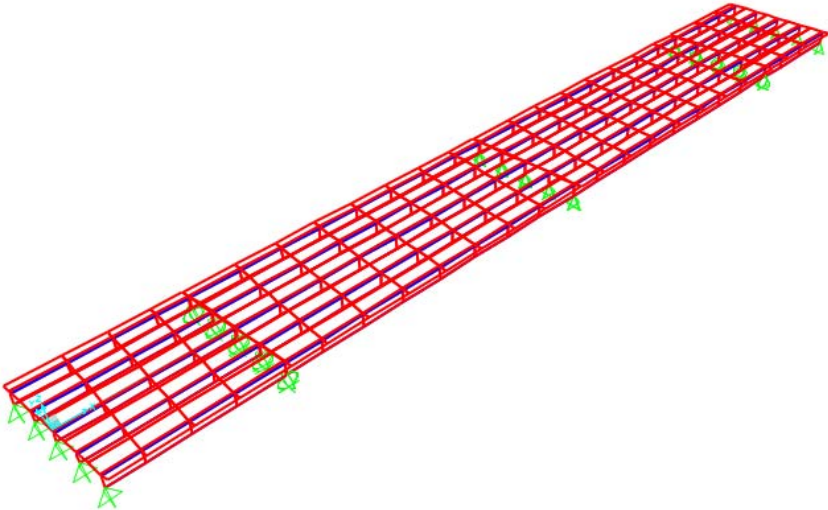
Finite Element model of CEX95200

In order to get a full understanding of the thermal behavior of this prototype bridge, six models were made with two types of thermal analyses: (1) Temperature Gradient (based on AASHTO, Zone 2); (2) Thermal Expansion (based on temperature increase or decrease within 100°F, which is for the extreme case).

These models are: (1) Current bridge model; (2) Bridge with 3 ECC link slabs; (3) Bridge with 3 ECC link slabs and change of boundary conditions (bearings); (4) Bridge with 3 UHPC link Slabs; (5) Bridge with 3 UHPC link slabs and change of boundary condition; (6) Bridge with 2 ECC link slabs and 1 UHPC link slabs with the change of bearings.

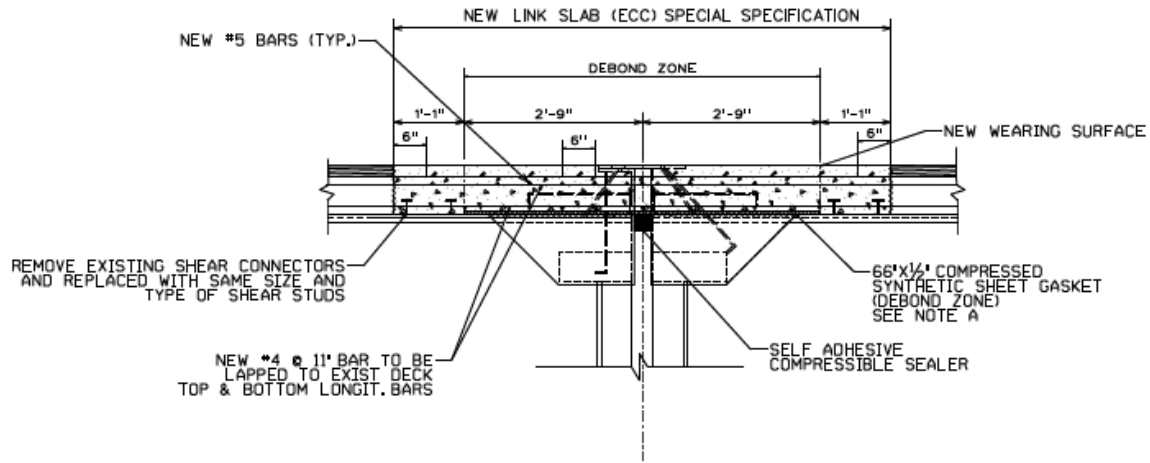
PROPOSED ECC LINK SLAB

Details based on the design procedure and special provisions for both ECC and UHPC link slabs were delivered on March 23, 2018 and the proposed sections are summarized here for

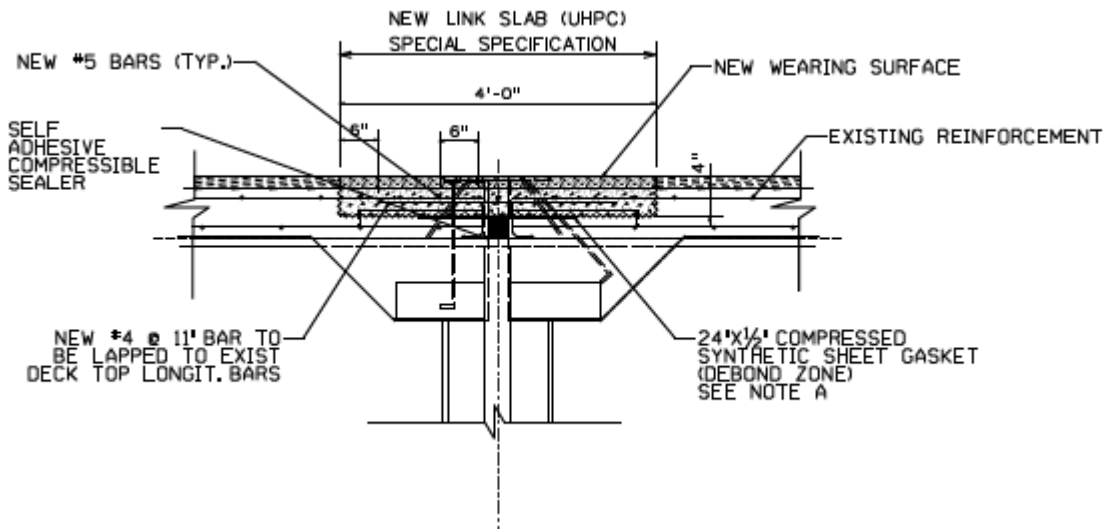
PROPOSED UHPC LINK SLAB

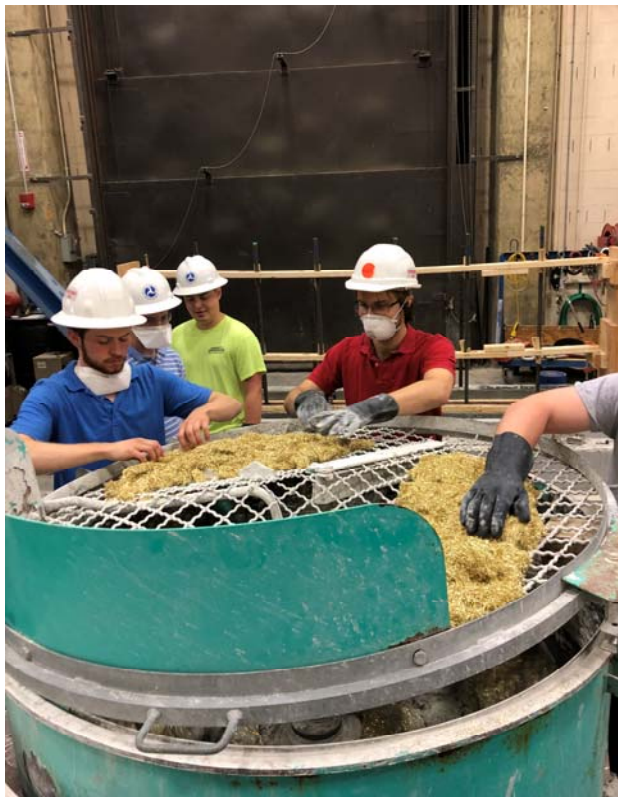
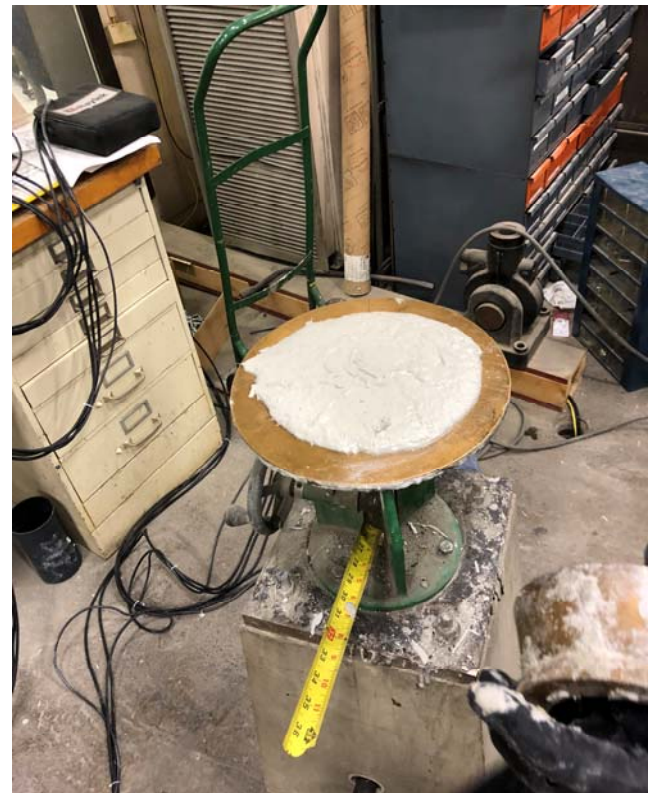
UHPC mixing in FHWA structure lab

Finally, FHWA and Larfarge have stricken a deal on July 2018 that we may obtain the 50-lb premix UHPC free of charge from the large quantity FHWA ordered. Visit 2018 to FHWA/TFHRC was made on July 18, 2018 to witness the UHPC mixing and carried back 50-lb premix and admixtures for our own test. Photos for the FHWA mixing demonstration and the research team own mixing practices are shown below.

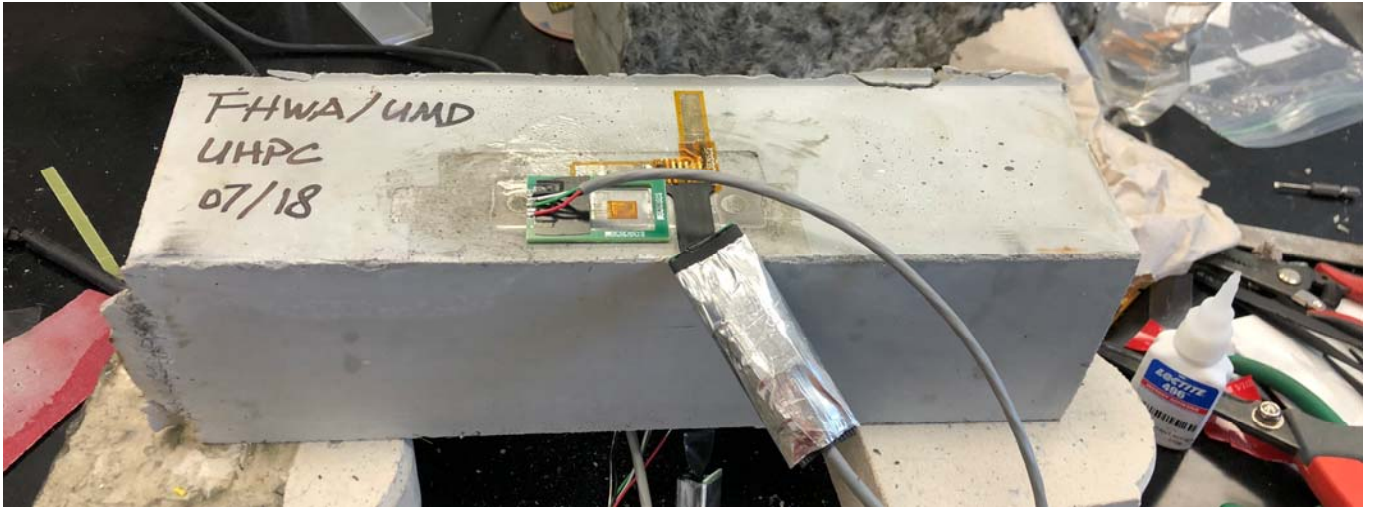
UHPC prism with embedded and surface strain gauges

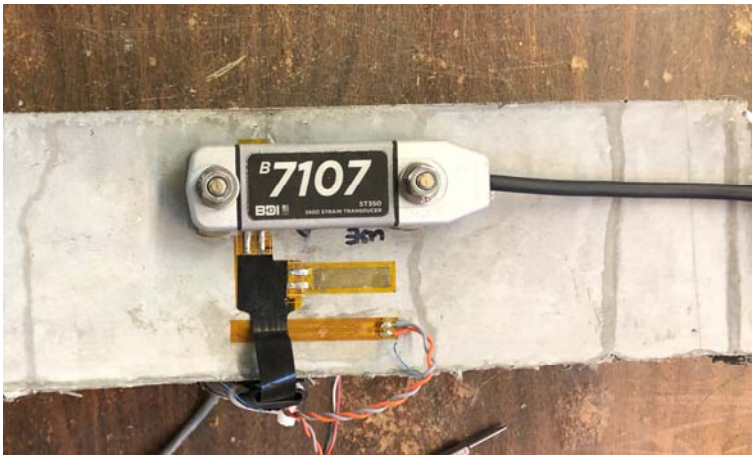
ECC prism with embedded strain gauges and BDI Strain Transducer

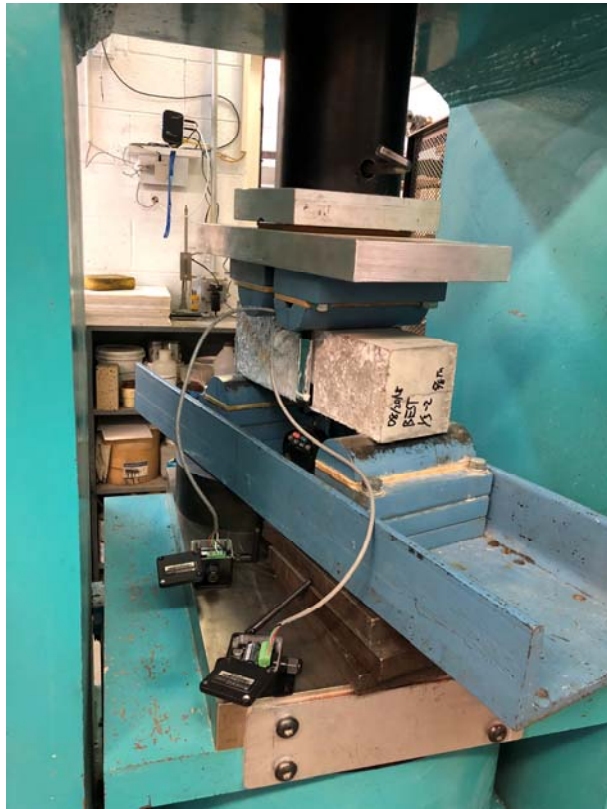
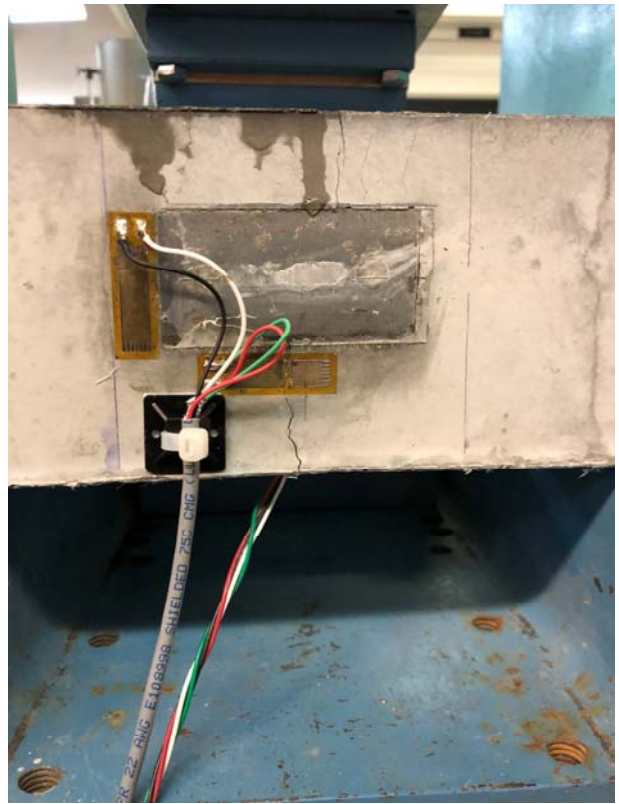
Four-point bending test with embedded wireless strain gauges

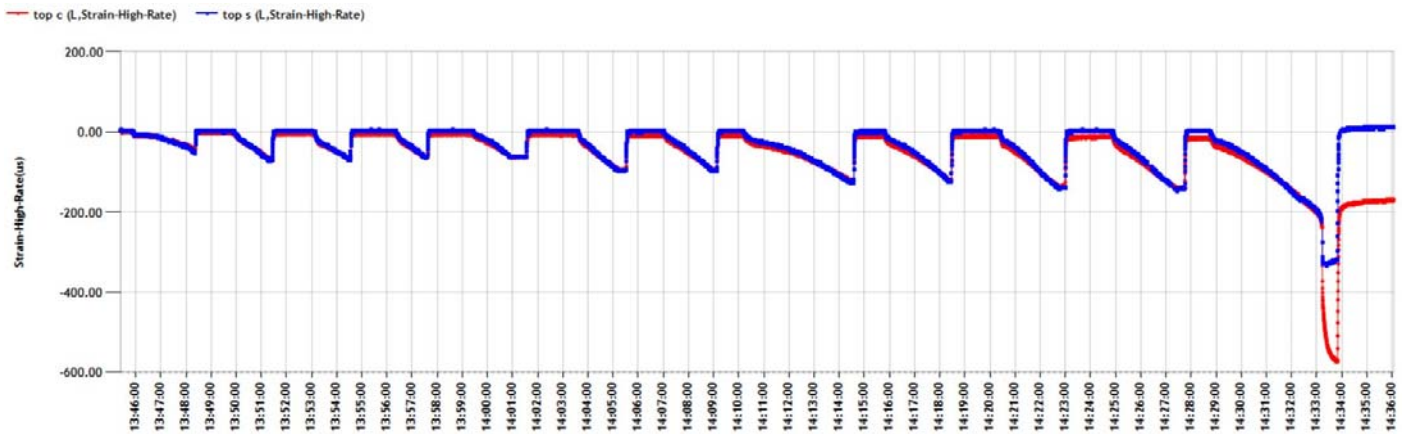
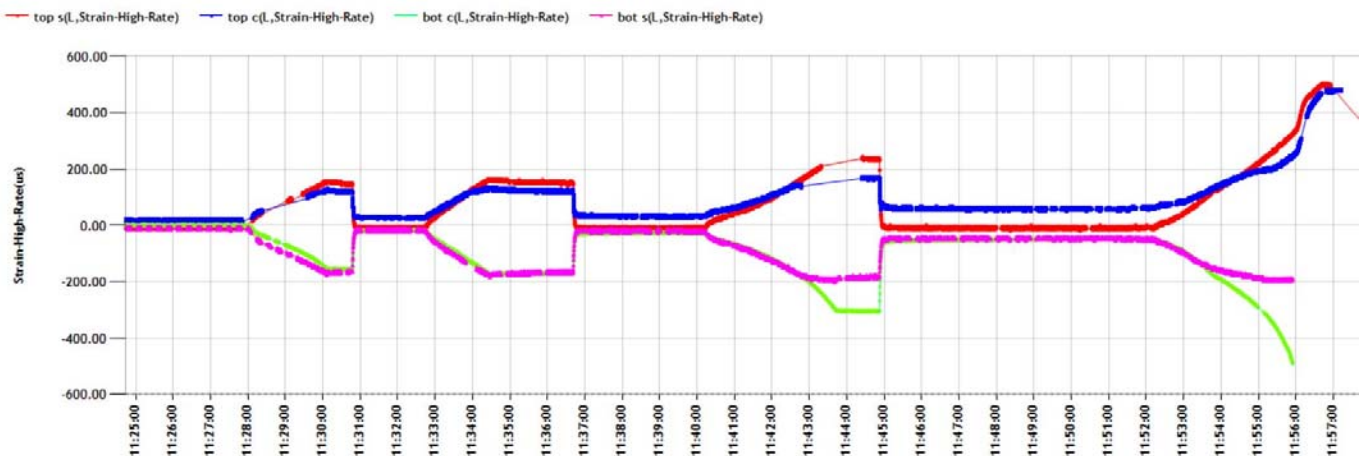
Compression and tension zone strain variation with cycle loading from surface and embedded strain gauges

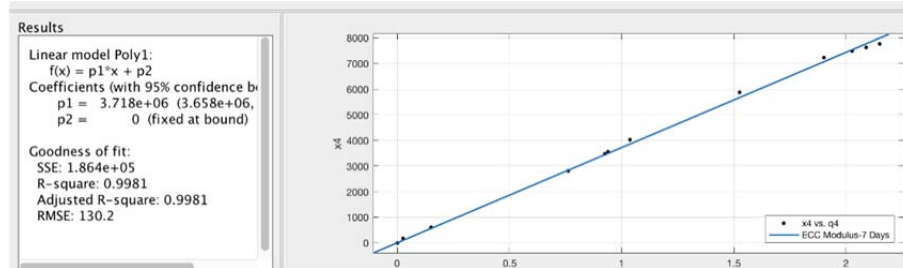
This test follows ASTM C469/C469M—14 Standard Test Method for Static Modulus of Elasticity and Poisson's Ratio of Concrete in Compression to determine the modulus of elasticity (Young's) of one ECC specimen. The specimen is a 3×6 cylinder using bonded strain gauge and unbonded compressometer. The deformation and the corresponding load are recorded. The modulus of elasticity of this specimen at 7 days was calculated as approximate 3,718 ksi by curve fitting (Figure 1). Based on ECC major physical properties, the range of Young's modulus is around 2,500 ksi – 5,000 ksi (ECC Material, Structural, and Durability Performance, Victor Li, 2007).

Figure 1 - Curve fitting method for Young's modulus

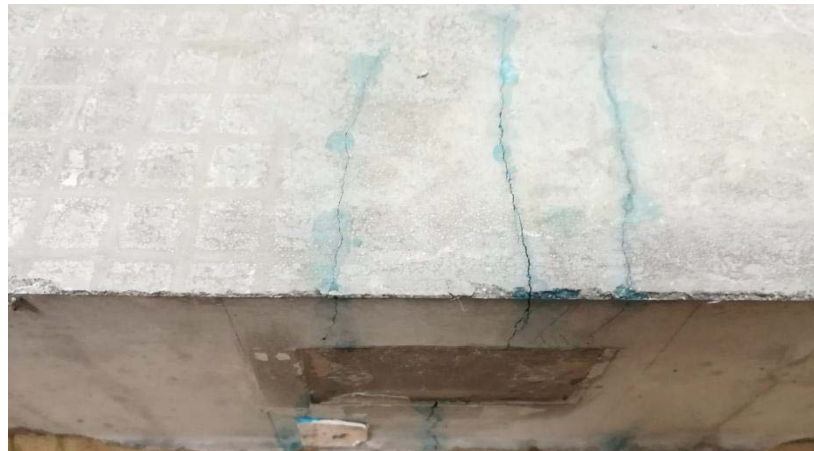
During three-point bending test, fine cracks might form but invisible. Fine cracks are assumed as main contribution for ductile performance in ECC material. After tests, colorful pigment could be used to indicate fine cracks and crack propagation. The following pictures (Figures 2 and 3) identified fine cracks successfully.

Figure 2 - Fine cracks identification

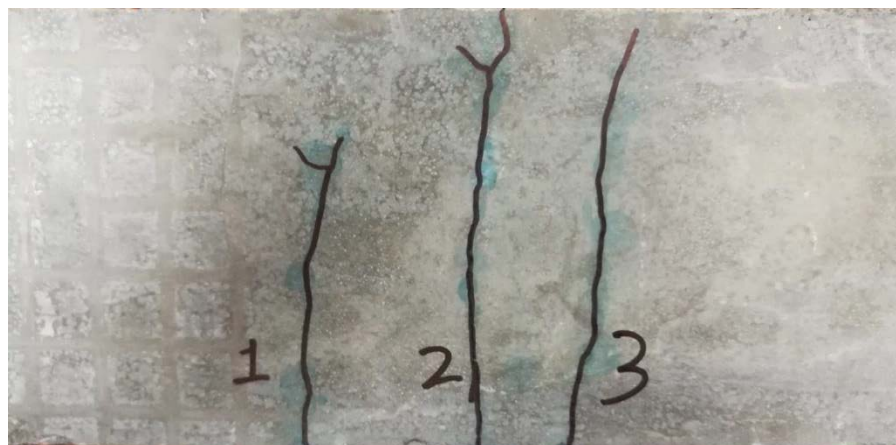
Figure 3 - Cracks propagation and distribution

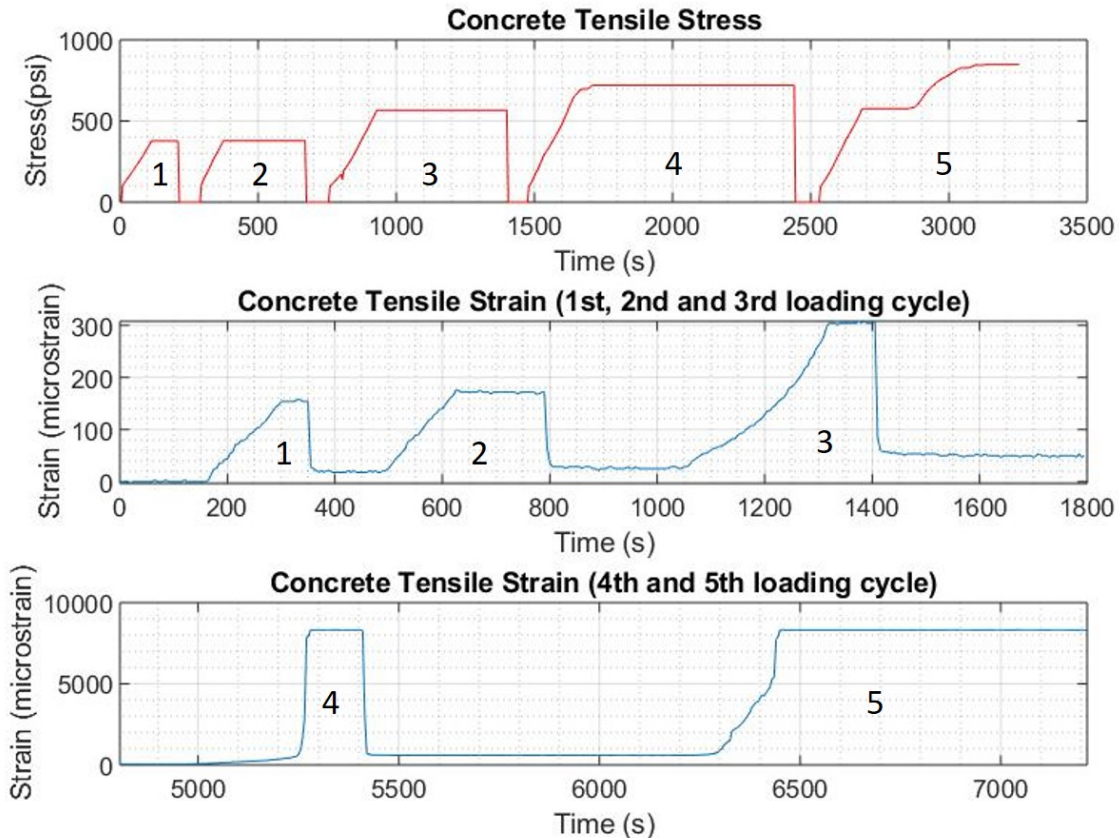
To simulate cycle loading in the field, three-point bending tests were conducted repeatedly with increasing loads. Figure 4 demonstrates the stress and strain data recorded in the test. The specimen was loaded cyclically until failure. The wave shapes of the plots correspond to five loading cycles; namely, from left to right, each peak on the graph represents the first, second, third, fourth and final loading cycle, respectively.

Figure 4 - Stress and strain by cyclic loading

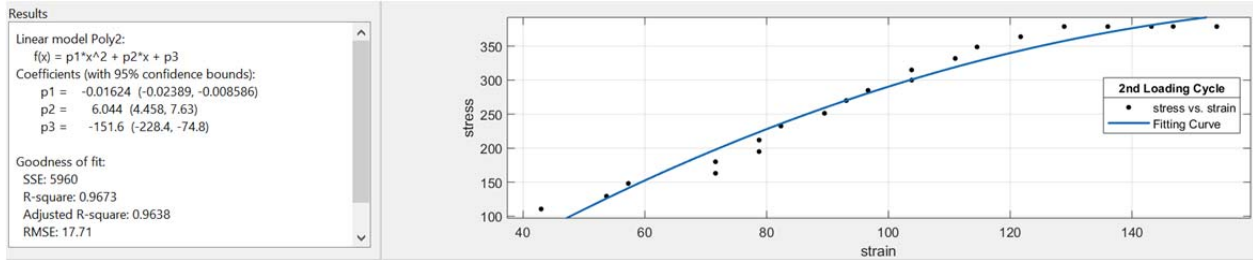
Based on experimental data, two-stage plots representing stress-strain relationship were generated by curve fitting method in Figures 5 and 6. Specifically, Figure 5 represents the stress-strain curve during which the specimen was undergoing the second loading cycle. Figure 6 shows the stress-strain relationship when the specimen was experiencing the fourth loading cycle, approaching to failure state. Comparison of the two graphs indicates that the slope of the stress-strain curve remains relatively constant in early stages (lower loading) and decreases as the specimen was approaching its failure state. Hence, it can be concluded that the ECC material was within its ductile region.

Figure 5 - Curve fitting for the 2nd loading cycle

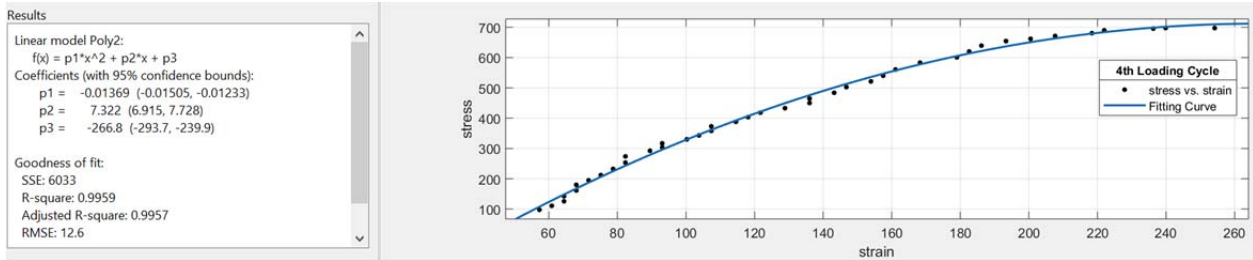
Figure 6 - Curve fitting for the 4th loading cycle

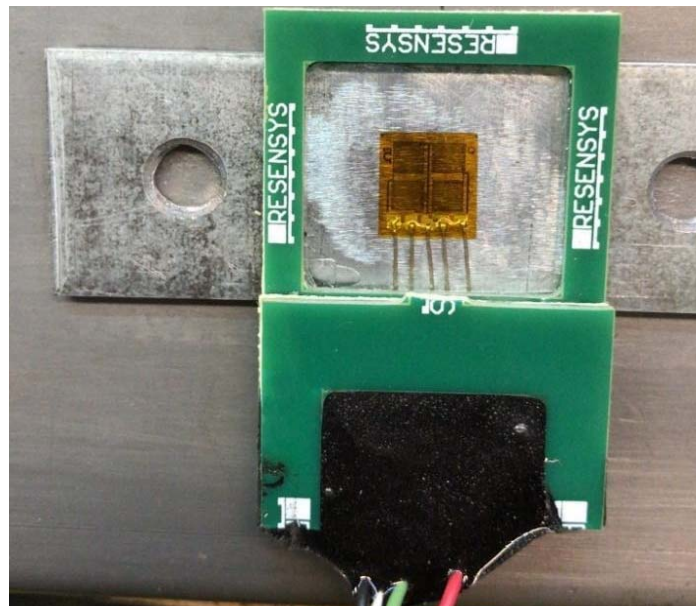
Among 14 three-point bending tests, 35 strain gauge sensor systems were used, and 10 sensor systems failed. The survival rate of overall sensors is about 71%. To simulate field condition, strain gauges were pre-installed on a small steel plate as a sensor system shown in Figure 7 below and then the sensor system was buried during concrete pouring (Figure 8). 83% of steel plate sensor system functioned during the three-point bending test process.

Figure 7 - Strain gauge installed on steel plate

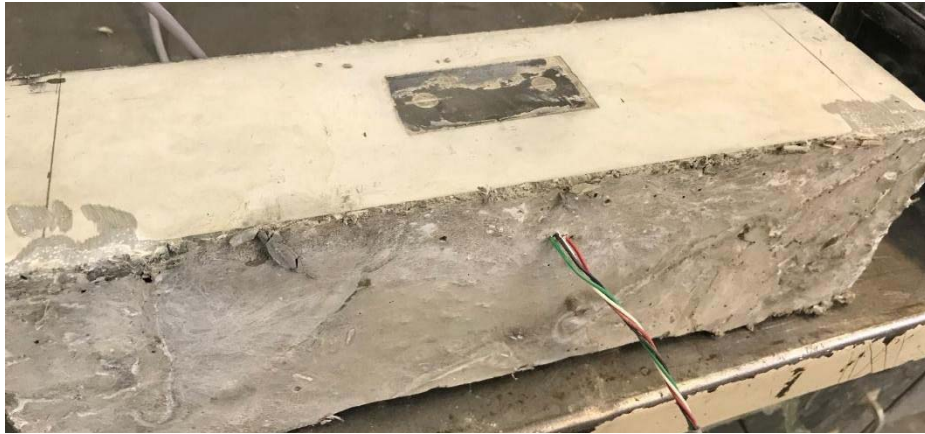
Figure 8 - Buried sensor system after concrete pouring

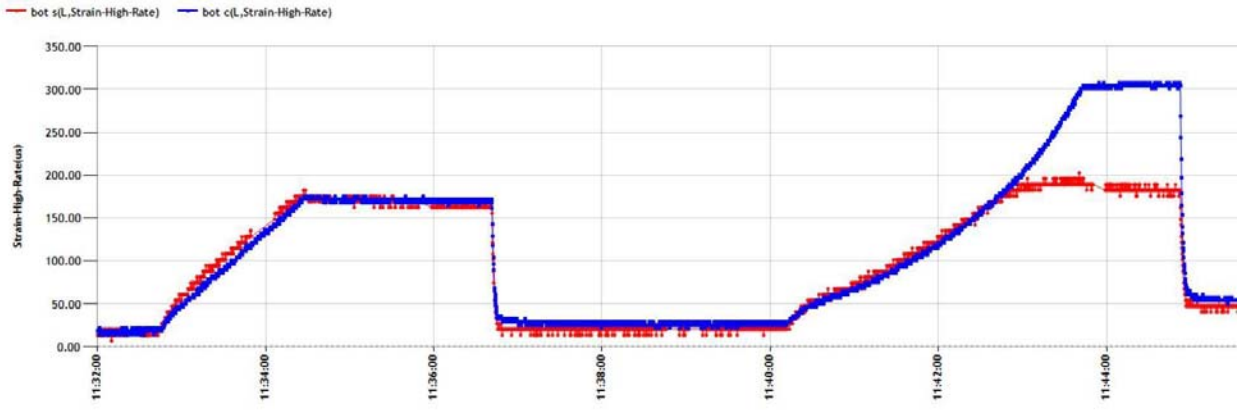
The feasible measurement range mentioned above is a linear calibration relationship between concrete strain and steel plate sensor system. For compressive strain measurement, the feasible ranges of steel plate sensor system are up to 890×10^{-6} (UHPC) and 340×10^{-6} (ECC). For tensile strain measurement, the feasible ranges of steel plate sensor system are 304×10^{-6} (UHPC) and 200×10^{-6} (ECC). When concrete strain exceeds these feasible ranges, measurements from concrete surface and sensor system become diverse as shown in Figure 9. Based on strain design calculation, ultimate factored compressive strain could be covered by feasible measurement range in either UHPC or ECC. However, the ultimate factored design tensile strain of UHPC and ECC are higher than feasible measurement ranges. Regarding tensile strain above feasible measurement range, further nonlinear or multistep calibrations are needed for steel plate sensor system in order to measure higher concrete tensile strain.

Figure 9 - Strain measurement from concrete surface vs steel plate

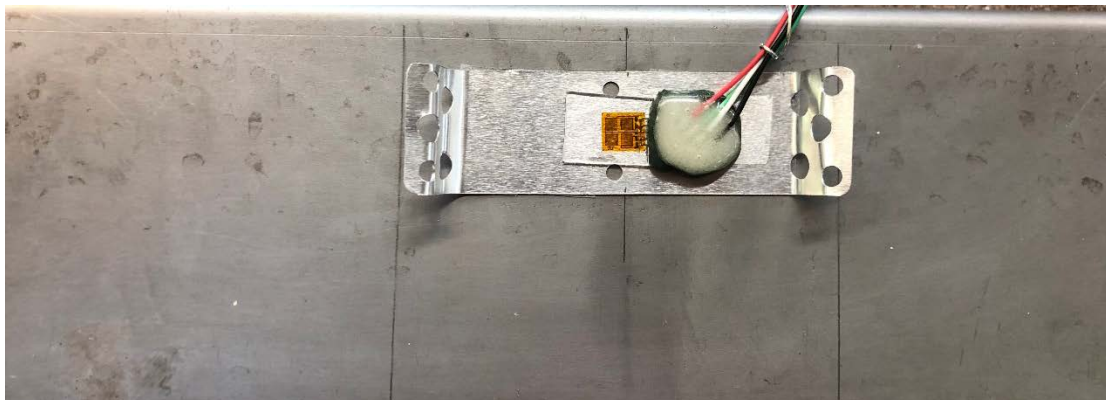
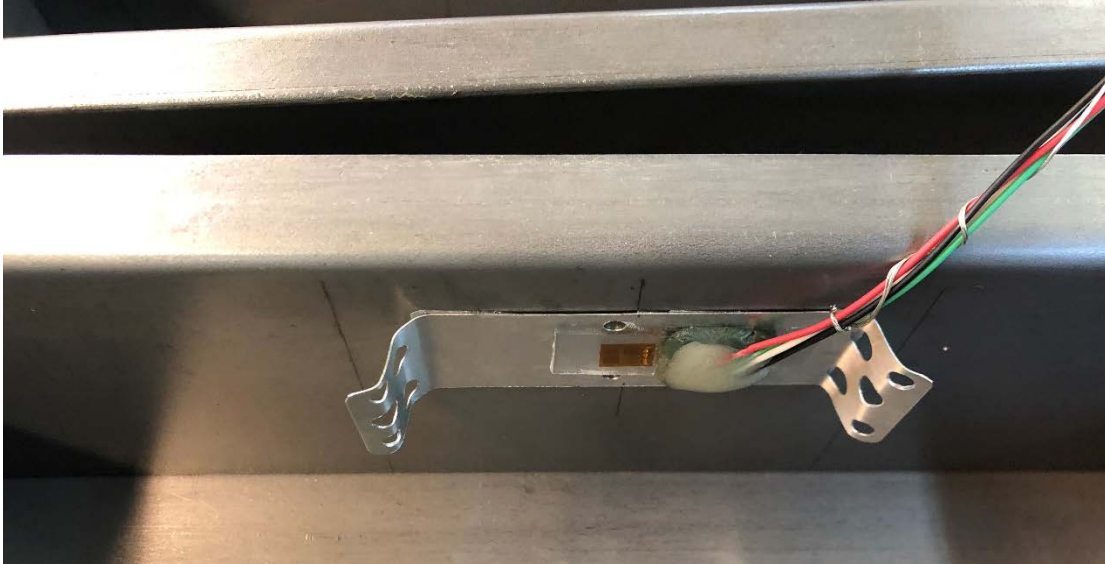
The new sensor is designed as table-shape with few small holes that avoid blocking concrete along cross section shown in Figs. 1&2. The strain detected by updated sensor system is consistent with strain detected by concrete surface before nonreversible deformation. The sensor system could stably detect strain up to 350×10^{-6} shown in Figs. 3&4 which cover FEM truck load simulation result. When applied load is higher than 4000 lbs, nonreversible deformation occurs. The nonreversible deformation might be fine cracks which are invisible but successfully detected by sensor system. While fine cracks form and concrete performs in ductile, sensor system could consistently detect strain up to 1000×10^{-6} in our best case shown in Fig. 4.

Figs.1 & 2 Updated Sensor System pre-installed before concrete mixing

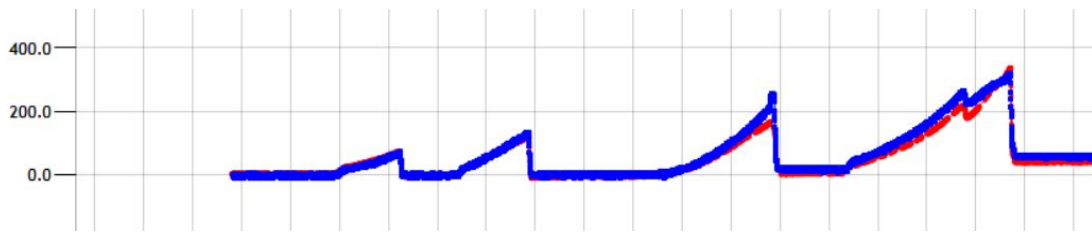
Fig. 3 Fine cracks occur after 4th cyclic loading

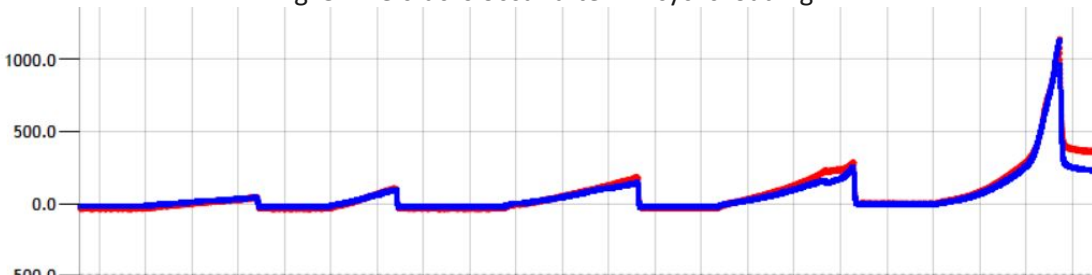
Fig. 4 Sensor system successfully detects strain up to 1000×10^{-6}
